▼ REPORT INTO A FIRE AT THE SUFFOLK
FOOD HALL ON 27 JANUARY 2010

TS10124-R01

for:
Kingspan Ltd
GreenField Business Park No 2
Greenfiled
Holywell
Flintshire
CH8 7HU

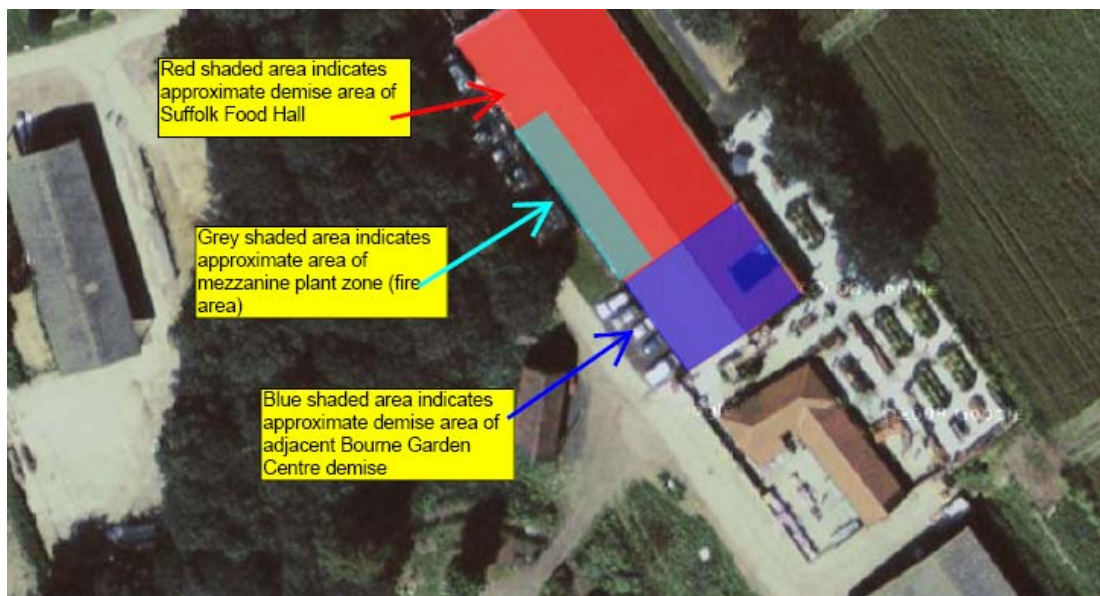
Figure 1 - Plan of building marked up to show location of tenant demises and fire area

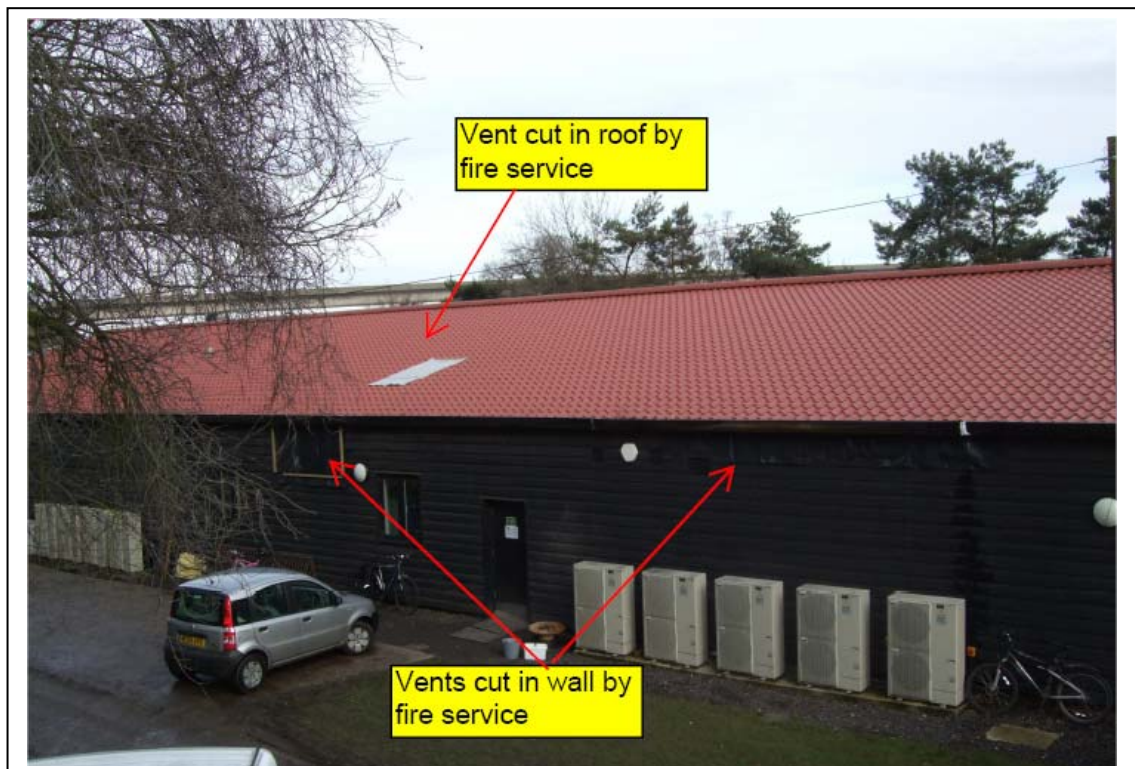
3.9 Oliver Paul reported that the fire service took the decision early in the fire-fighting intervention to create an opening through the roof membrane to ventilate the fire location. By virtue of it being a frosty morning, the fire service decided to create a vent in the location where it appeared that the fire intensity was greatest due to fire-induced thawing of frost on the upper surface of the roof in this location. The location of this roof vent is marked up on the photograph shown in Figure 4. The fire service also cut vents in the external wall at the locations shown. The left-most wall vent was into the mezzanine plant area at low level.

Figure 4 - photograph showing vents created by fire service.

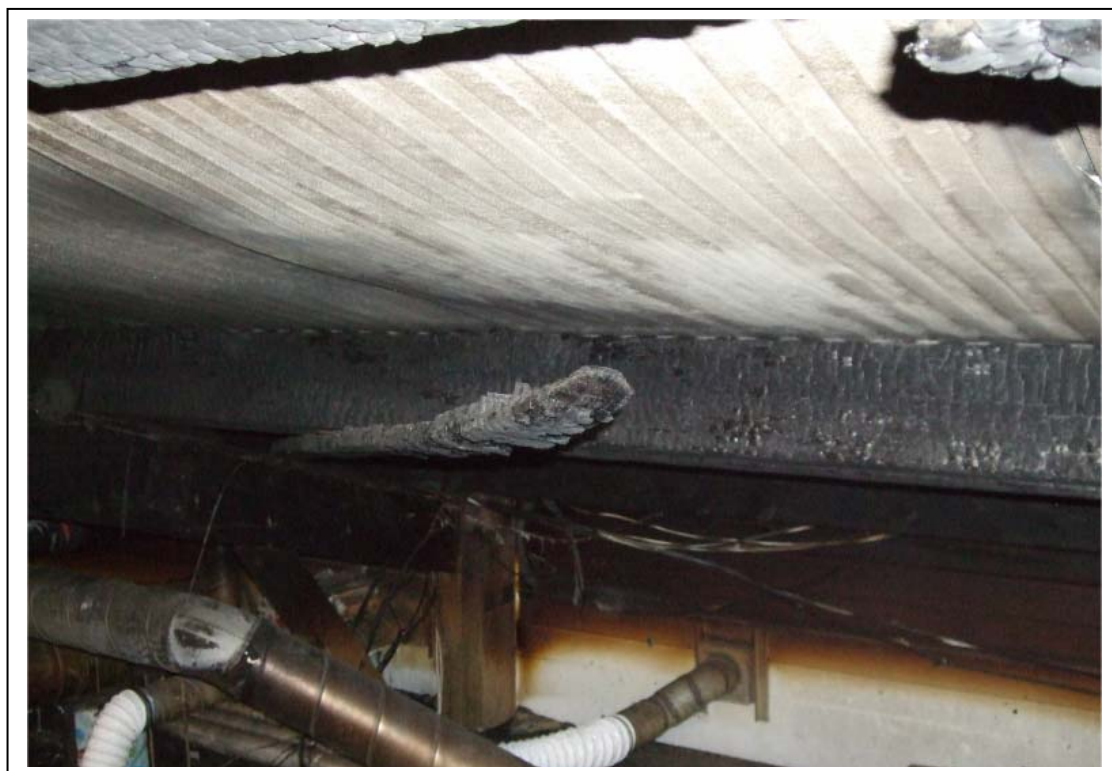
- 4.1 This section lists the key observations from the site investigation carried out by M Bullock on 3rd February.
- 4.2 The mezzanine plant area was accessed through a doorway at the top of an open accommodation stair leading to the 1st floor cafe area.
- 4.3 It was evident that some of the services in the fire affected area had already been replaced in order to reinstate the business function, although some fire damaged equipment and materials remained in the area.
- 4.4 Figure 5 shows a photograph taken in the mezzanine plant area looking down the slope of the pitched roofline towards the internal face of the western external wall. The extent of the hot smoke layer development can be seen by the height at which the internal face of the external wall is smoke stained above deck level.

Figure 5 – view of fire damaged area looking down towards the eaves

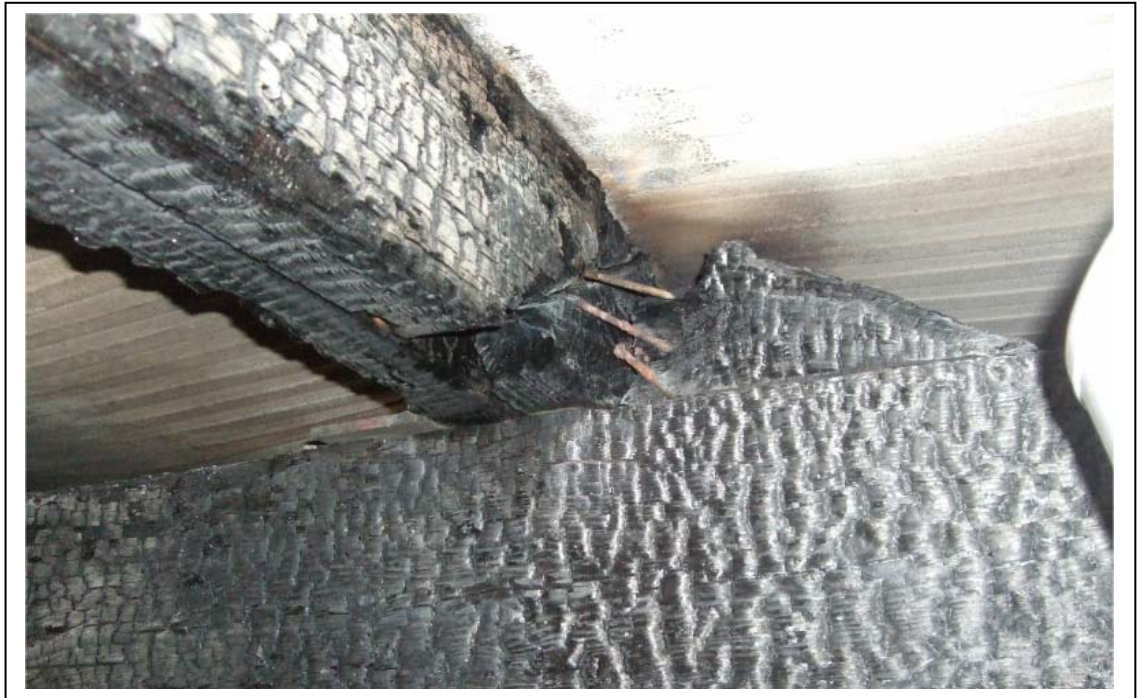
- 4.7 The position where charring of roof support timbers was most significant was approximately 2.7m to the south of the vent that the fire service cut through the roof membrane. At this location, the depth of charring to the main timber rafter was approximately 15mm. Figure 6 shows a photograph of a charred roof support portal at this location.

Figure 6 – charring of roof support portal at position of maximum fire intensity

- 4.8 Based on softwood exhibiting a charring rate of approximately 20mm per half hour of exposure to the conditions of a standard fire resistance test, this indicates that the fire exposure to which the roof had been subjected was approximately equivalent to a 23 minute fire resistance test
- 4.9 At the location where the fire service had created the roof vent, it could be ascertained from the visual inspection that the fire exposure had resulted in partial through-thickness charring of the PIR core material of the roof membrane sandwich panels. Figure 7 shows a photograph of the core material close to the location where the fire had been most intense.
- 4.10 Whilst the PIR core was charred through part of its thickness, there was no evidence to suggest that the fire had been propagated through the insulating material core of the panel.

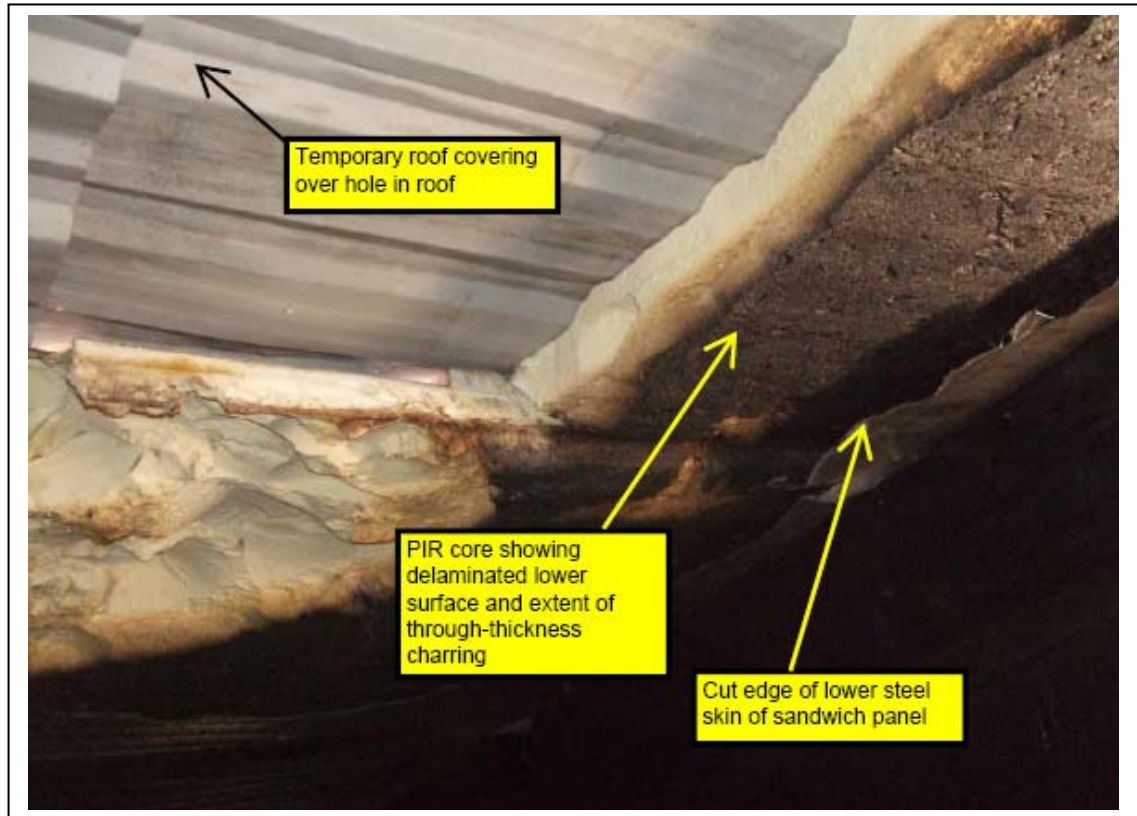
Figure 7 – charring of sandwich panel PIR core

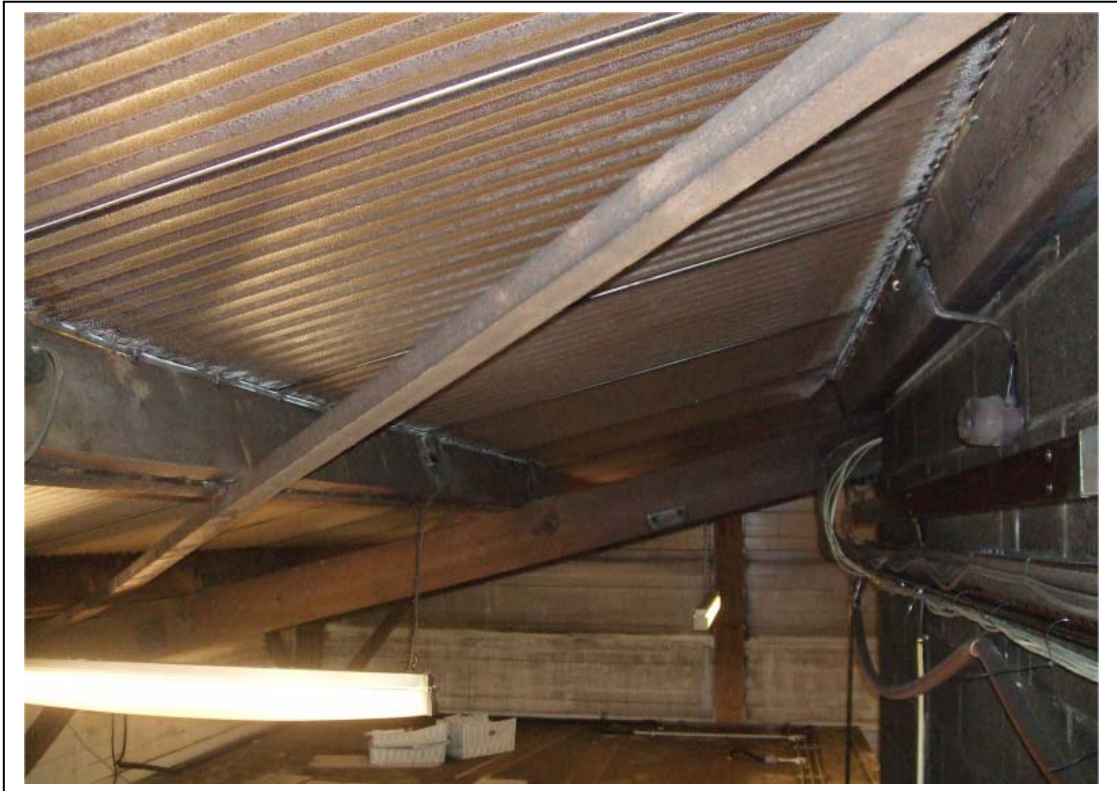
- 4.11 It was established that the lower skin of the roof membrane sandwich panels had delaminated from the PIR core over the parts of the mezzanine area that had been subject to the greatest fire intensity. This delamination was evident wherever there was evidence of charring of roof timbers. The further north along the mezzanine area, the lesser was the fire intensity and, at a point over the ground level chillers, it was apparent that the roof membrane from this point to the northern extremity of the building was not delaminated. Figure 8 shows a photograph of the roof looking northwards from the plant mezzanine area. Although the timbers have been stained by hot smoke, there was no evidence of penetrative charring of the roof timbers in this area.

Figure 8 – view looking from the plant mezzanine level towards north wall

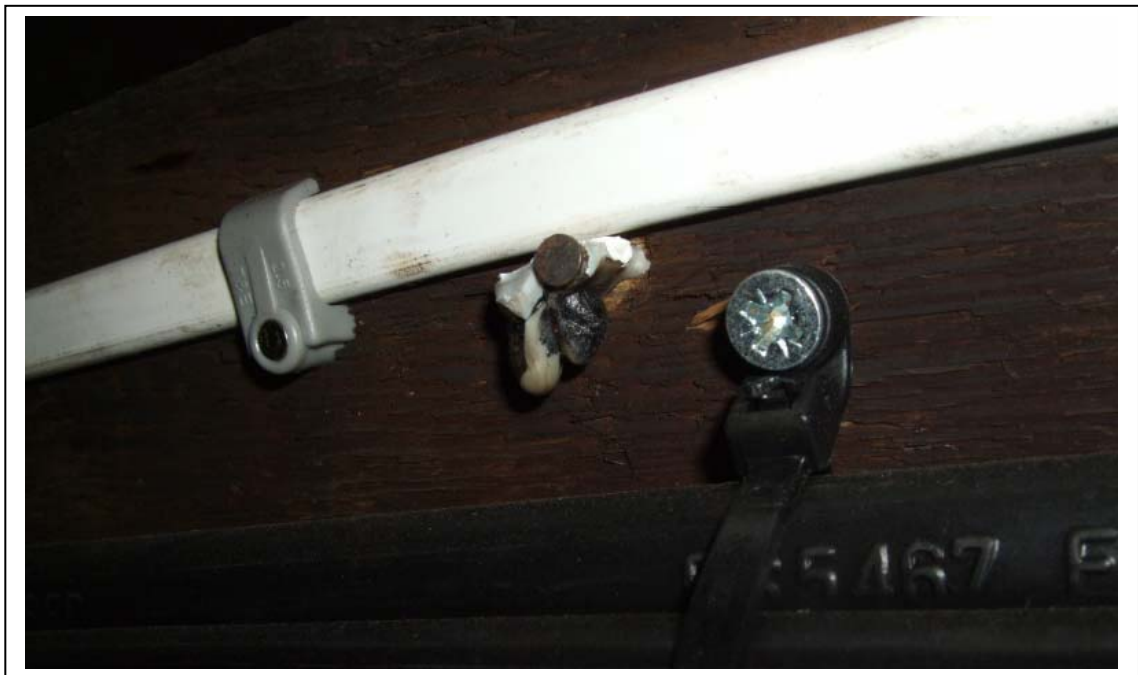
- 4.12 Figure 9 shows a photograph of smoke stained timbers in this area where new electrical services have been replaced and where previous PVC cable fixings had melted. At this location the lower skin of the roof membrane exhibited delamination from the core.

Figure 9 – melted cable clip on smoke stained timber

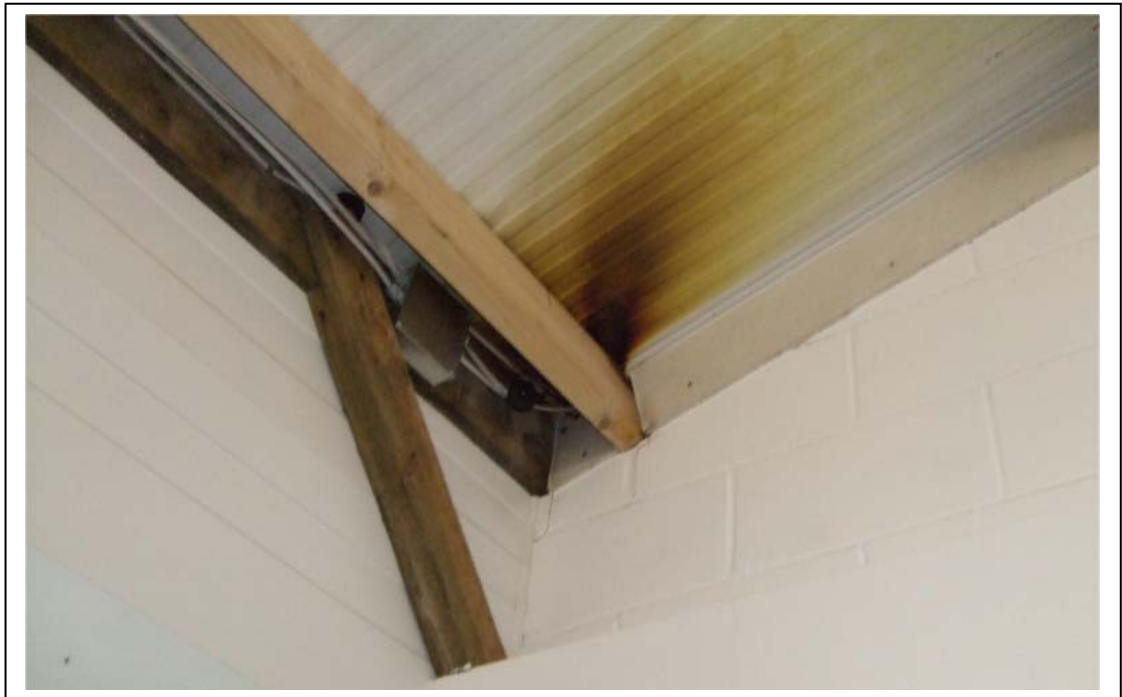
- 4.14 Figure 11 shows a photograph taken from inside the adjacent Bourne Garden Centre demise looking up at the underside of the roof cladding at the south western corner of the wall to the mezzanine plant area.

Figure11 - photograph of underside of roof in adjacent demise

- 4.15 The photograph shows evidence of smoke penetration through gaps and also indicates that the fire did not spread along timber roof support members or services passing through this wall.
